# Leica Geosystems Release Notes

**Product** Leica BLK360 Imaging Laser Scanner  
**Date** 1st July 2021  
**From** Björn Beutelspacher

## Leica BLK360 Imaging Laser Scanner – Firmware v2.1.0

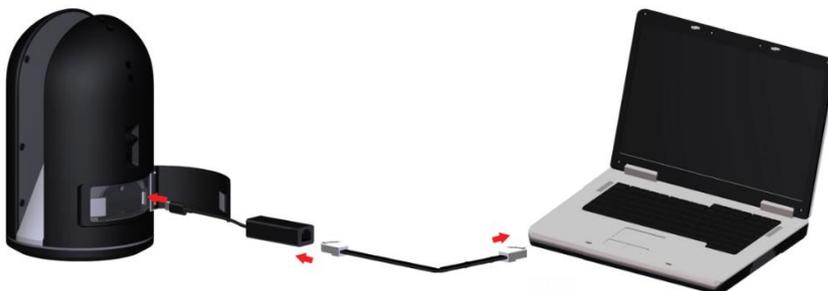
- USB-C to Gigabit-Ethernet adapter (on BLK360 side)
- Ethernet LAN cable
- PC with Gigabit-Ethernet (can be via Gigabit-Ethernet adapter as well)

In case the computing device does not have an ethernet port, a 2<sup>nd</sup> USB-C to Gigabit-Ethernet adapter can be used.

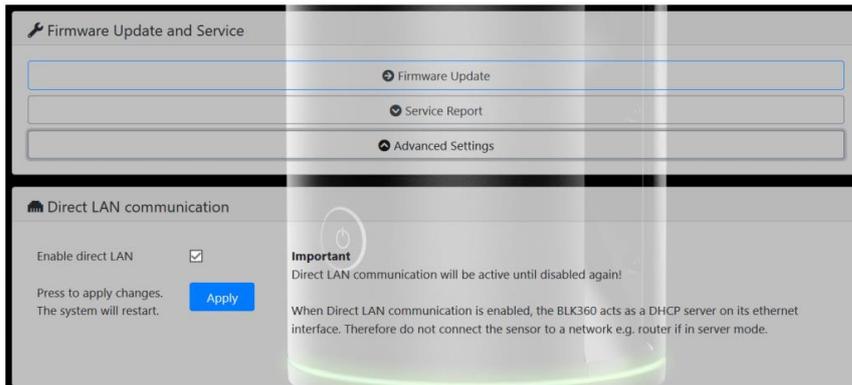
On the BLK360 Web interface, go to the Advances Settings:

Set the tick-mark for “Enable direct LAN” and press Apply.

This will now enable a build-in DHCP Server. The direct LAN settings configures the Leica BLK360 as DHCP server, which provides an IP to the connected computing device.

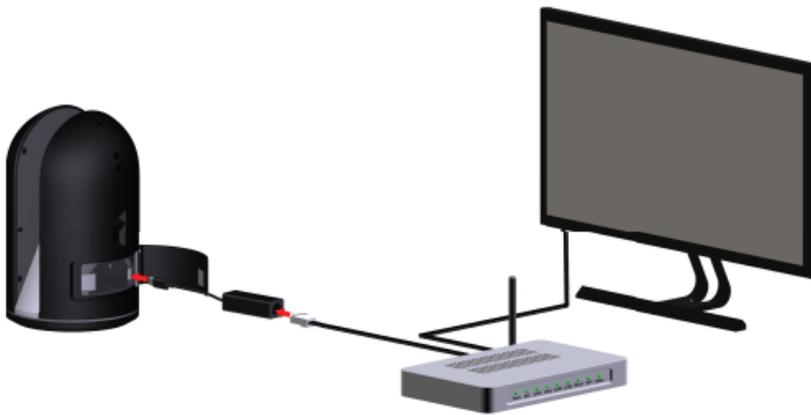
The 2nd option is to connect the BLK360 to a network, e.g. a router. This option requires a given network structure.

Furthermore the used router with BLK360 must be in the same subnetwork as the computing device to ensure Leica Cyclone Data Manager or Leica Cyclone Register 360 can connect to the device.

The direct LAN settings configures the Leica BLK360 as DHCP server, which provides an IP to the connected computing device. Since the IT network usually provides an IP to the connected devices (in this case the Leica BLK360) this could cause issues in the network.

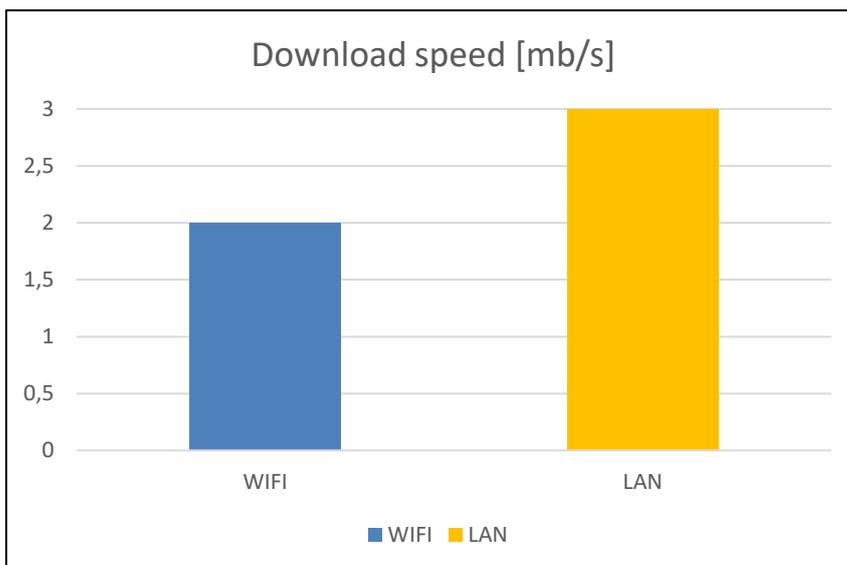
The download speed using a LAN communication is in general 50% faster than using WiFi. This is valid for direct data transfer to a computing device and using a LAN network structure.

The speed of the data transfer not only depends on the used method (WiFi or LAN) but changes as well with the used computing device. For the setup using a LAN infrastructure (router) other factors will affect the speed as well. For example the general traffic within the network.

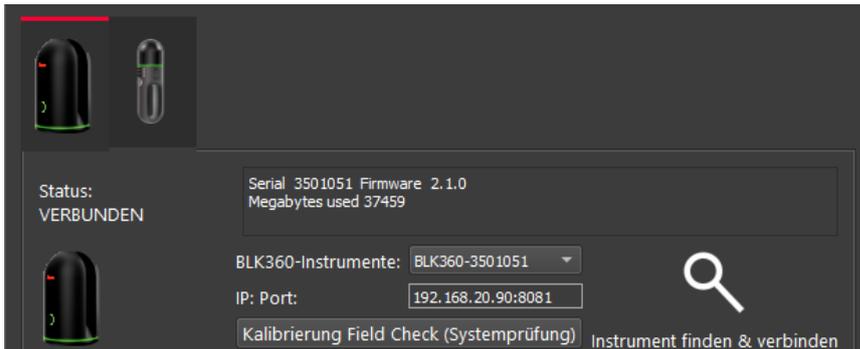
The Ethernet cable must be standard twisted, not crossed.

The maximum length of the Ethernet cable including the USB-C connector(s) must not exceed 3 meters.

To connect to the Leica BLK360 using a LAN connection, install the latest available apps of Cyclone Data Manager respectively Leica Cyclone Register 360/ Cyclone Register 360 BLK Edition. Older version do not support the LAN cable feature.
